Gear Oil Symons Crushers, Iron Ore

CJC™ Application Study

Sishen Iron Ore, South Africa

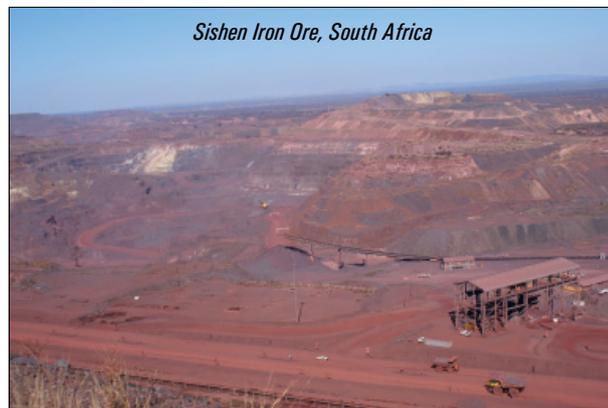
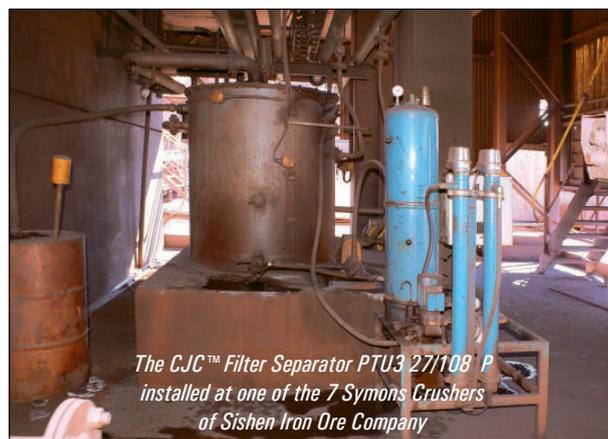
The CJC™ Filter Separator PTU3 27/108 P installed at one of the 7 Symons Crushers of Sishen Iron Ore Company

CJC™ Filter Separator PTU3 27/108 P-E2H1PW with a flow rate of 400 litres/h, 2 x 4.4 kW preheaters and **4 x CJC™ Filter Inserts BLAT 27/27**, capable of retaining up to 16 litres of contaminants.
